NASA CR-120518

CHARACTERIZATION OF EXOTHERMIC BRAZING COMPONENTS
SKYLAB EXPERIMENT M552

By H. E. Pattee and R. E. Monroe
Battelle Columbus Laboratories
Columbus, Ohio 43201

December 1973

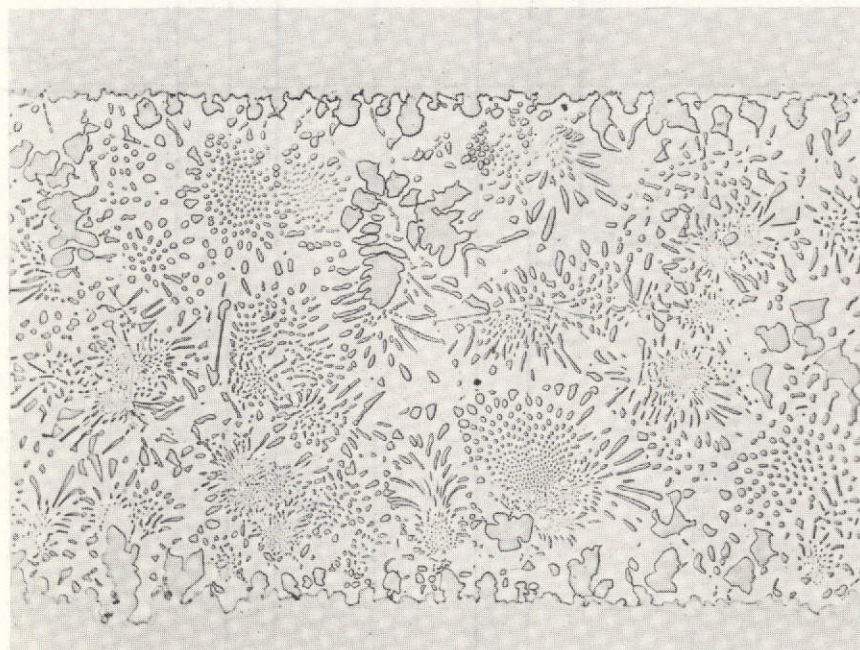
FIGURE I-4. SECTION MCN-2.1 (0 mm) MICROSTRUCTURE

Selected areas of this joint are shown in the as-polished condition at 250X and 500X in Figures I-4 and I-5, respectively; the area covered by Figures I-4 is also shown in the etched condition at the same magnification in Figure I-6. The microstructure between the joint interfaces is largely comprised of a second phase in a high silver matrix. A phase produced by the reaction of the filler metal with the base metal is also present. Etching appeared to have the same effect on this phase as it did on the phase along the joint interface. The reaction of the base metal with the molten filler metal is clearly evident in the attached photomicrographs. The width of the zone resulting from this reaction was about 0.001 inch.

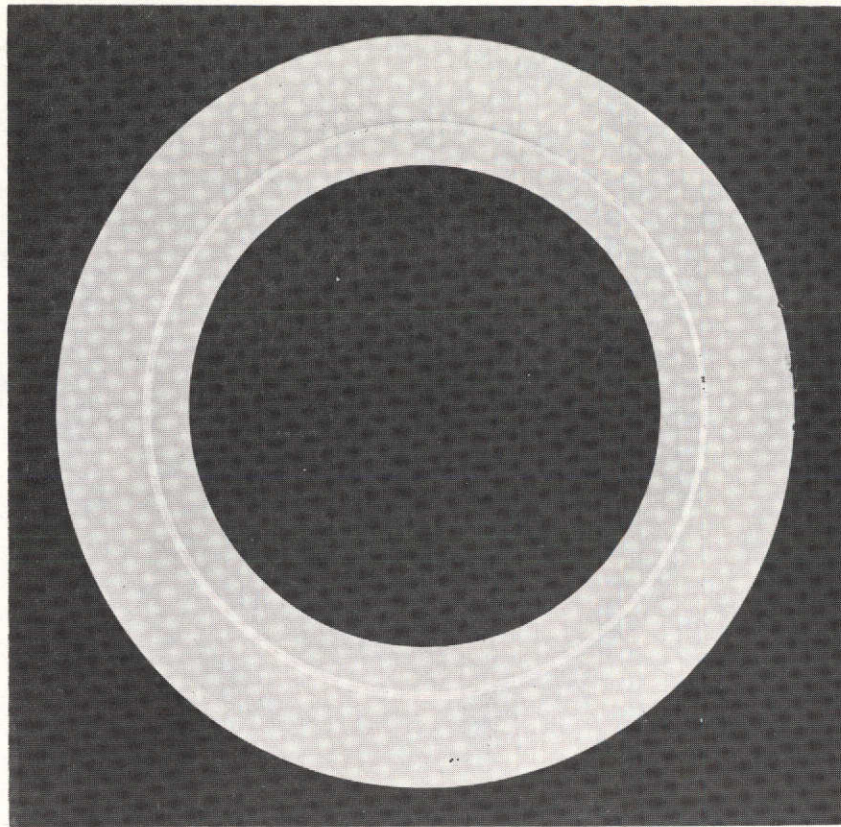
FIGURE I-7. MACROGRAPH OF SECTION MCN-2.2 (2.5 mm)

12 o'clock and 3 o'clock locations in Figure I-7. (The 3 o'clock position corresponds to the location of the isotope tracer in this sample.) These voids, one of which extended across 70 percent of the joint, could have formed as the result of insufficient filler metal in this area. They could have also formed if filler metal drained from this area into an area deficient in filler metal. Their presence was not noted in the interpretation of the radiographs of this sample. Voids at the 3 o'clock location are shown at 250X in Figure I-8.

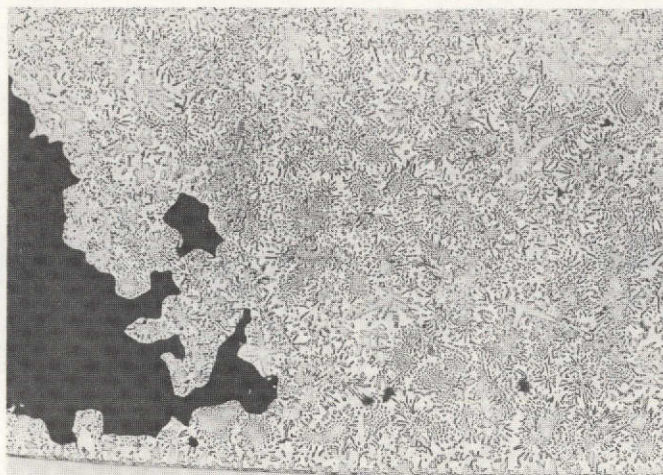
FIGURE I-10. MICROSTRUCTURE OF BRAZE ALLOY IN RING
GROOVE - SECTION MCN-2.3 (7 mm)

A section near the left-hand edge of the accumulated filler metal is shown at 100X in Figure I-10. There are some isolated voids in this area. The microstructure is largely comprised of a second phase and a phase resulting from the reaction of the filler metal with the base metal in a high silver matrix.

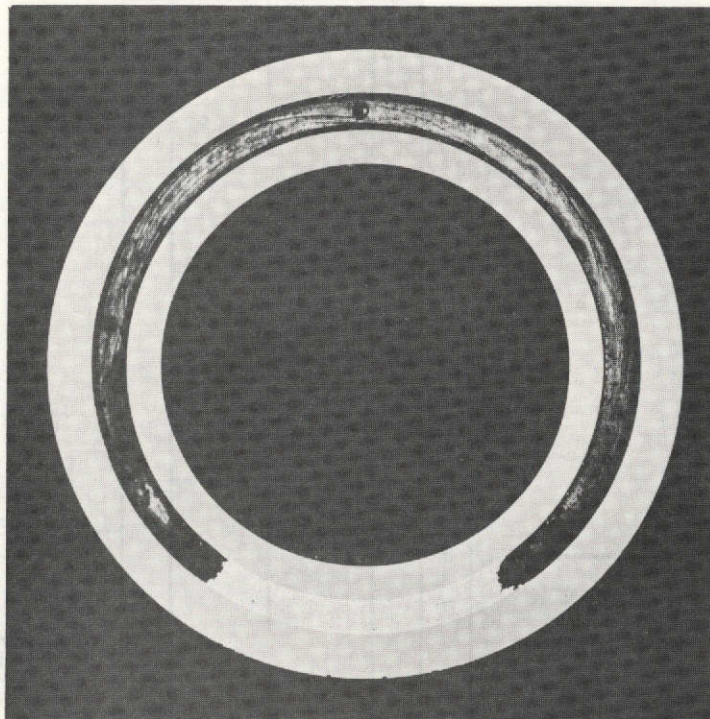
FIGURE I-13. MACROGRAPH OF RING GROOVE AREA -
SECTION MCN-3.2 (7 mm)

A circumferential section through the right-hand ring groove of this sample is shown at 4X in Figure I-13. The location of the accumulated filler metal indicates that the tube assembly was brazed in the orientation shown in Figure I-13. Considerably more filler metal remained in the ring groove of this sample after brazing than in the corresponding ring groove of Sample MCN-2 (Figure I-9). Apparently, the filler metal did not flow as well as it did in the previous sample. As observed previously, however, the surfaces of the ring groove were coated with a thin film of filler metal.

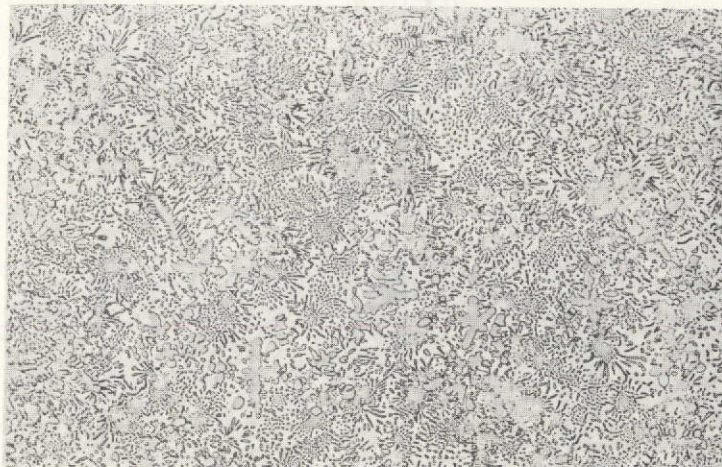
FIGURE I-14. MICROSTRUCTURE OF RING GROOVE AREA -
SECTION MCN-3.2

The microstructure of the accumulated filler metal is shown at 100X in Figure I-14. It is similar in appearance to microstructures examined previously.

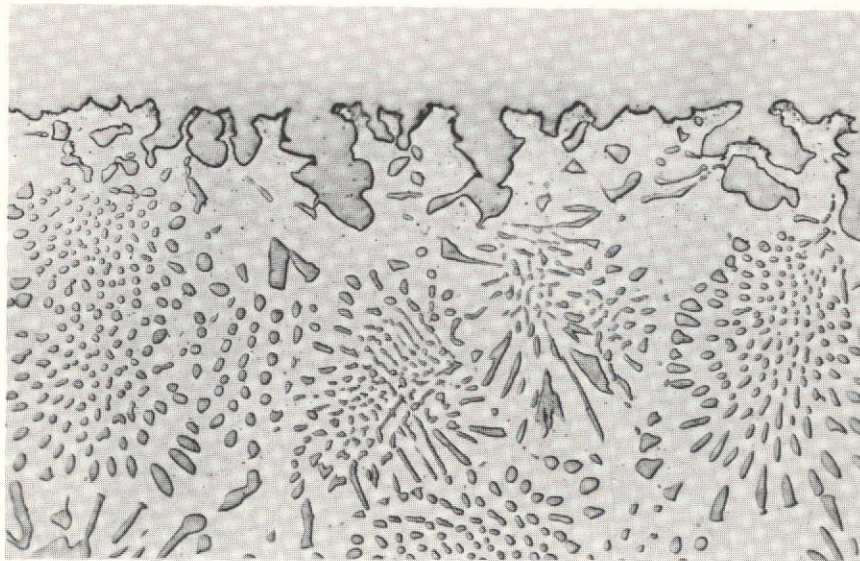
FIGURE I-17. MICROSTRUCTURE IN SECTION MCN-3.4 (15 mm)

A defect-free area of this joint is shown at 250X and 500X in Figure I-17. The joint microstructure is similar to that observed in various sections of Sample MCN-2. However, the length of the particles along the interface indicates that more reaction between the molten filler metal and the base metal occurred in this sample than in Sample MCN-2.

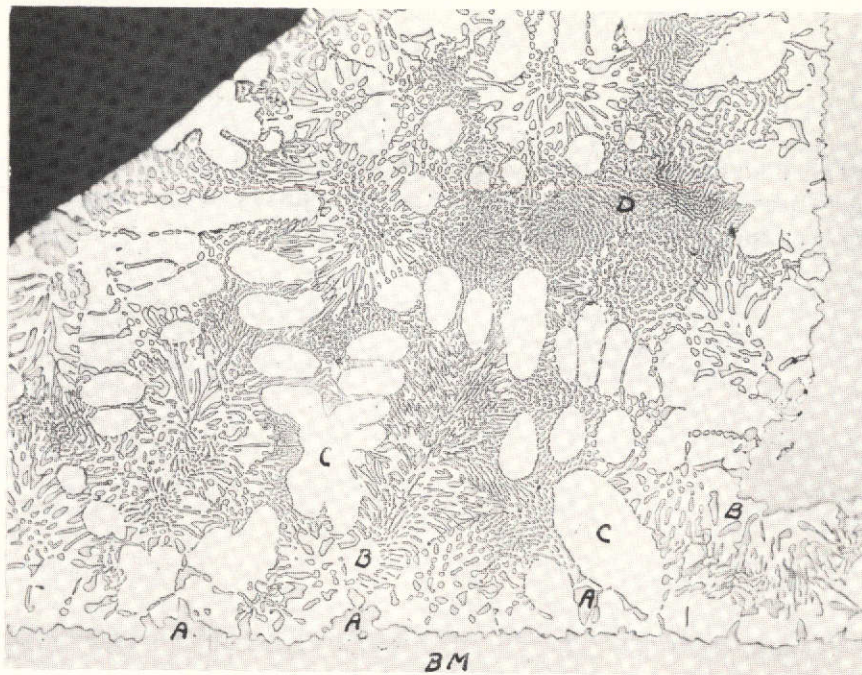
FIGURE I-21a. PHASES PRESENT IN TEE JOINT BRAZED AT 1500 F

An unetched section of the nickel tee-joint is shown at 250X in Figure I-21a; for direct comparison, a section from MCN-2 is shown at the same magnification in Figure I-21b (this figure is identical to I-4). The microstructures of these joints reflect differences attributable to the brazing conditions. The amount and distribution of the copper-rich phase (A in Figure I-21a and I-21b) indicates that more reaction between the base metal and filler metal occurred in the exothermically brazed joint than in the furnace brazed joint. However, the width of the reaction zone at the interface was comparable for both joints. The microstructure of areas at some distance from the joint interface differs considerably. In the furnace-brazed joint (Figure I-21a), there is a silver-rich dendritic phase (C) dispersed in a matrix of the silver-copper eutectic (D). In the exothermic-brazed joint (Figure I-21b), the following phases are present: a copper-rich phase (a), a phase that is essentially pure silver (B), and a phase that was not identified (C).

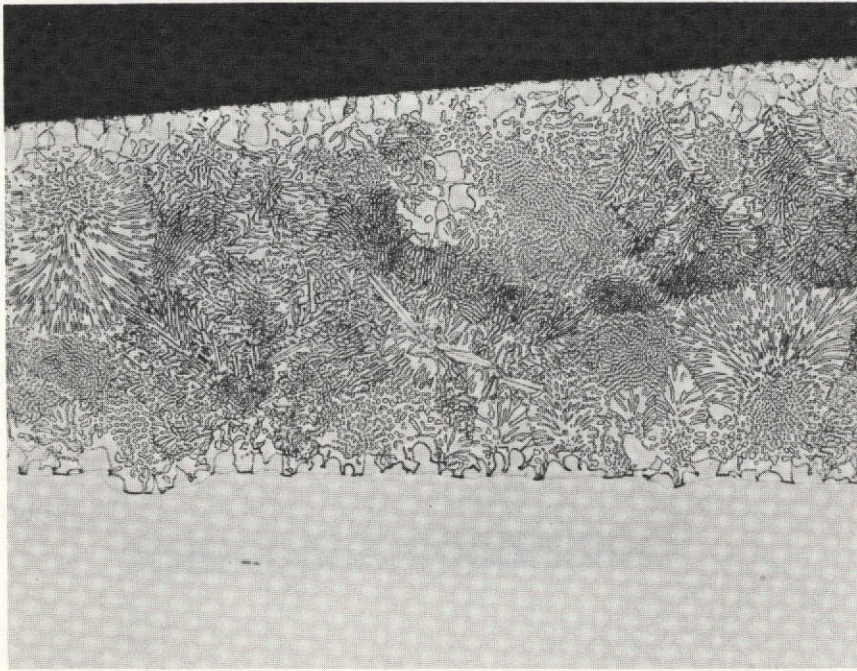
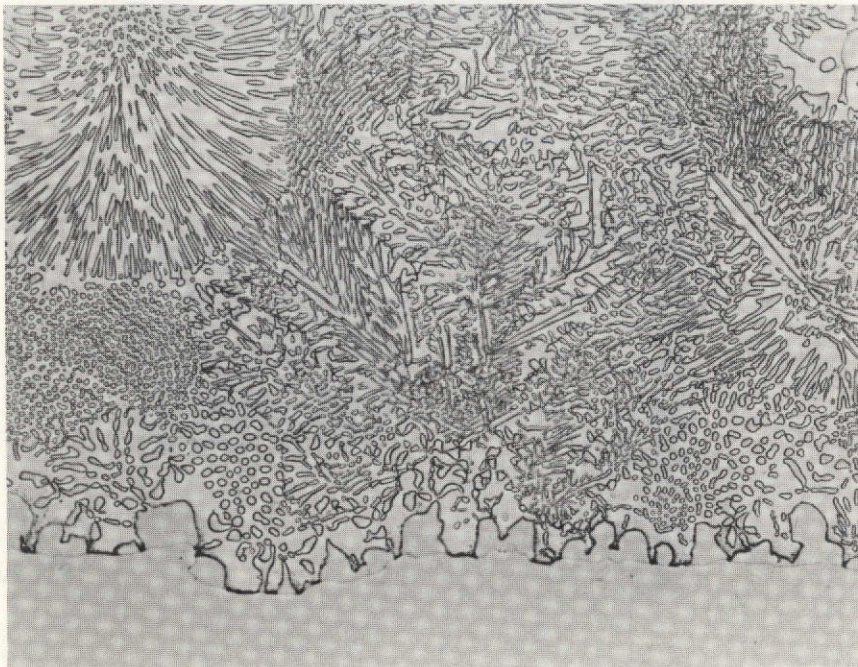
The microstructure of an area of accumulated filler metal is shown in the unetched condition at 250X and 500X in Figure II-6. Reaction between the base metal and molten filler metal at the interface is clearly evident. The microstructure of the bulk filler metal is quite complex, consisting of products from the base metal-filler metal reaction and possibly some silver-copper eutectic.

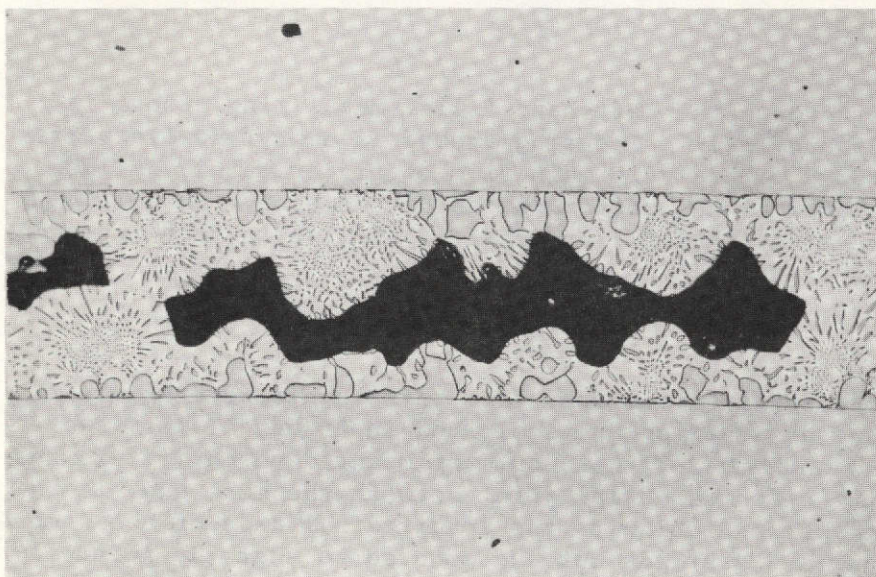
FIGURE II-8. SHRINKAGE VOIDS IN SECTION MCS-1.4 (15 mm)

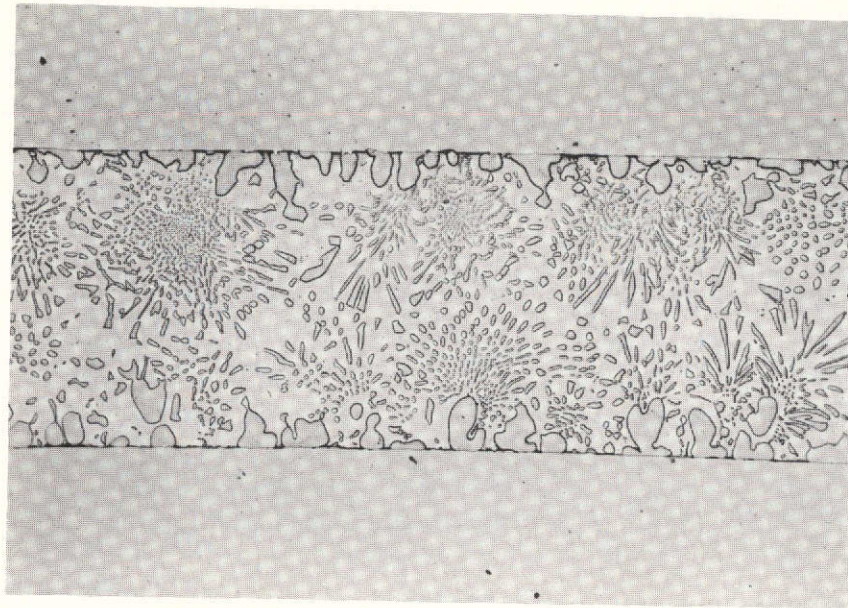
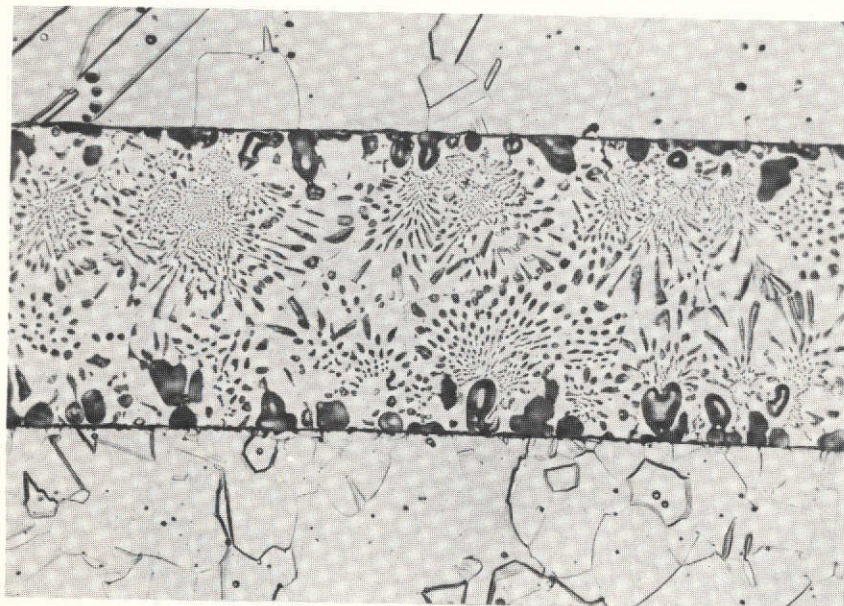
FIGURE II-14. MICROSTRUCTURE IN SECTION MCS-2.4 (15 mm)

were no void areas of significance. A section of this joint is shown in the unetched condition at 250X in Figure II-14a; the same section is shown etched in Figure II-14b. The joint microstructure appears similar to those observed in sections from Sample MCS-1.
